# IMPORTANT INFORMATION

Date: 13 October 2011

Product: Smooth SCAN-3 Laser

Smooth SCAN-BLUE IASER

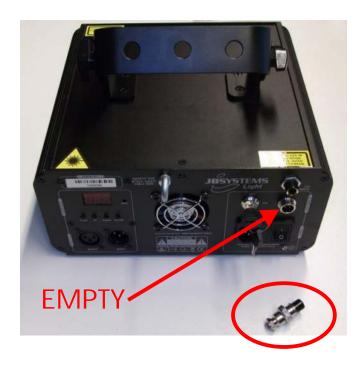
## **NO OUTPUT**

Recently we get a lot of lasers back with the complaint that the laser is not working / broken.

The lasers are NOT broken: according to the latest laser safety rules, the laser may not be able to work (produce laser output) when the INTERLOCK input is not used. So from now on the you should use the laser with the INTERLOCK connector inserted, **see pictures.**

In the current manuals this issue is not corrected yet: we will update the manuals of the products to make clear that the INTERLOCK input must be used. Sorry for the inconvenience caused.
